Manhole Inspection Summary

Manhole # S23GG_040MH

Location Address: **604 SCHOOL ST**

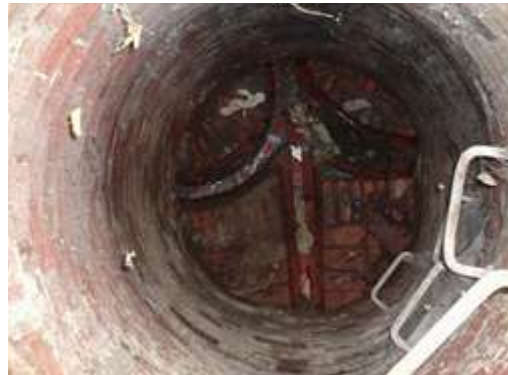
Top View

Evidence of surcharge - Bench debris.
Channel debris.

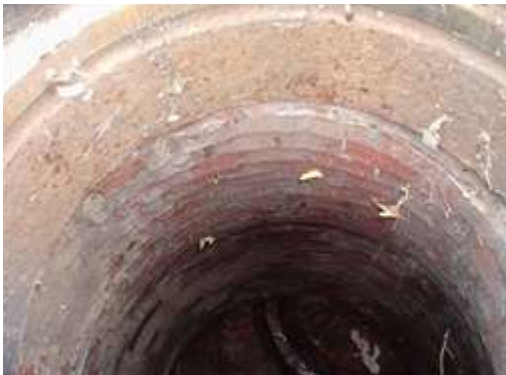
Defect

Frame leaks. Adjustment deterioration
and infiltration. Barrel infiltration - other
side.

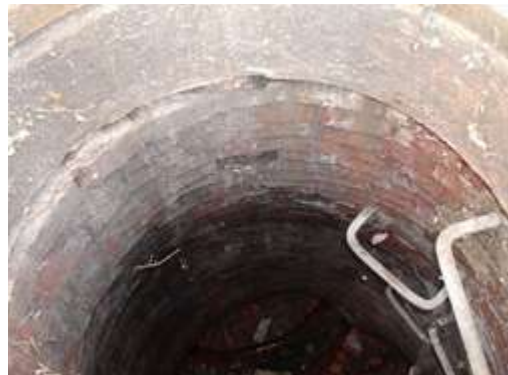
Defect

Frame leaks. Adjustment deterioration
and infiltration. Barrel infiltration.

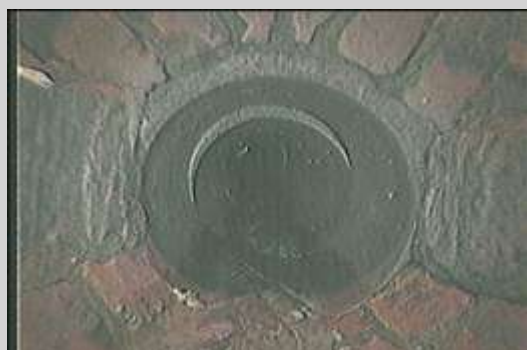
Pipe Out @ 12 O'Clock

Channel deterioration.

Infiltration: **None** Pipe Seal Cond: **Cracked**

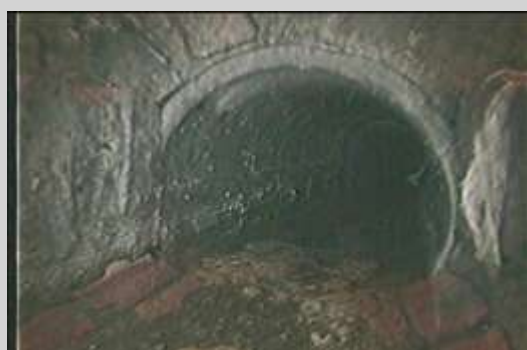
Pipe In @ 3 O'Clock

Deposits: ☐ None ☒ Mud ☐ Sludge ☒ Debris ☒ Grease

Silt Depth: **0** (in.) Deposits Extent: **Light**

Infiltration: **None** Pipe Seal Cond: **Cracked**

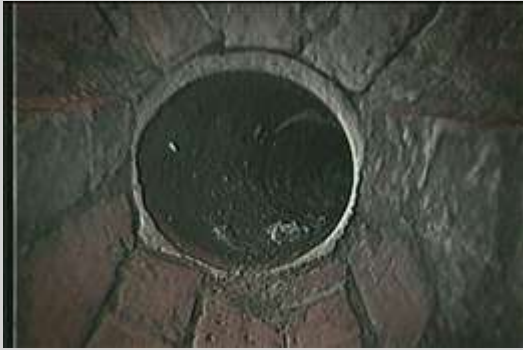
Pipe In @ 6 O'Clock

Deposits: ☐ None ☐ Mud ☐ Sludge ☐ Debris ☒ Grease

Infiltration: **Evidence**

Pipe Seal Cond: **Cracked**
